# Practical Turf Management – 5<sup>th</sup> Seminar Renovation of the Hong Kong Stadium Pitch

**Mr. Pako P C Ip**  
**Executive Manager, Tracks**  
**The Hong Kong Jockey Club**  
**6 June 2015**

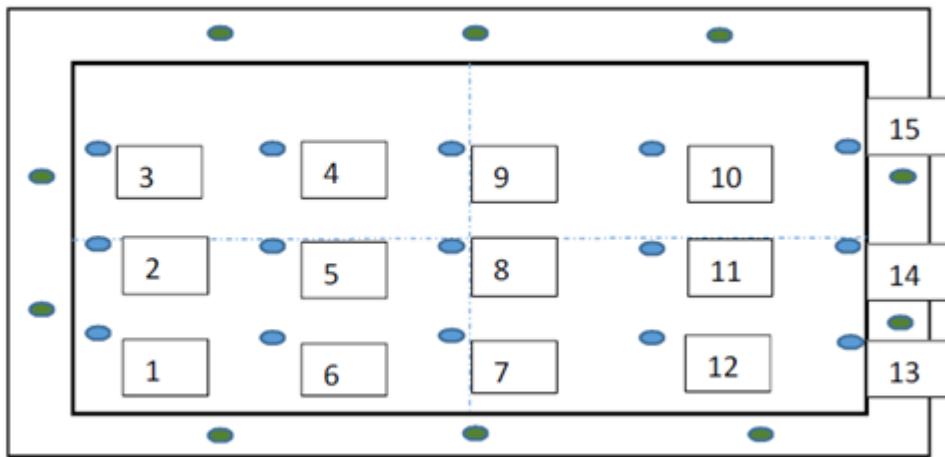
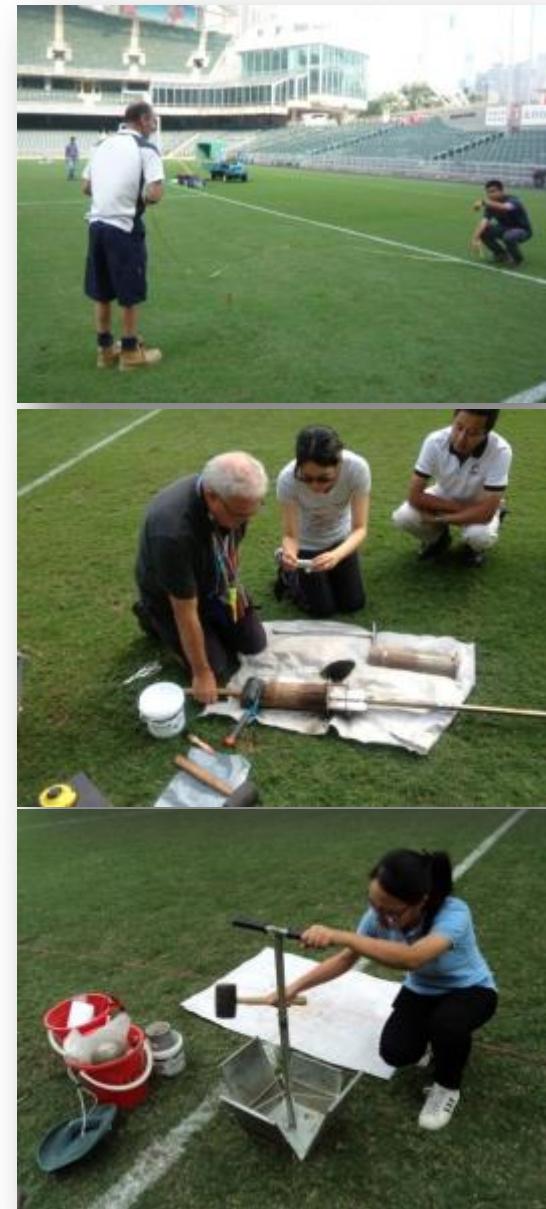
## 2. Sampling and tests Oct 2013

- 15 sampling sites around the pitch
  - especially high wear areas
- To view roots and profile
-

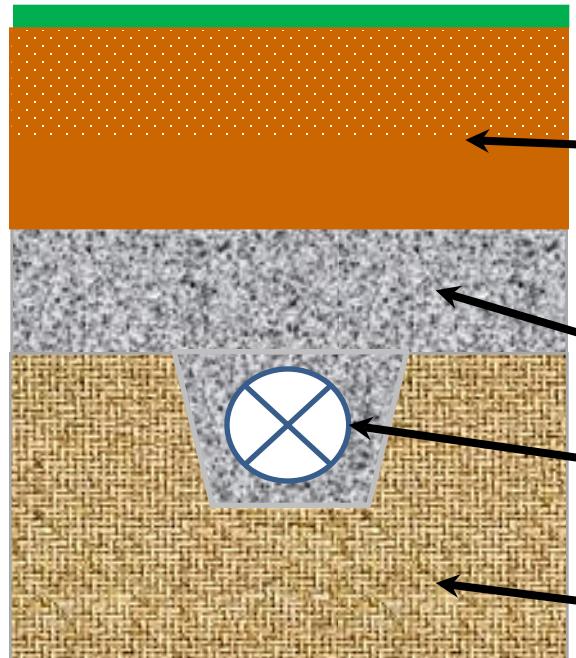
AS BUILT

- Top Dark Layer 50mm to 130mm in thickness
- Grey Sand Layer 0mm to 150mm in thickness
- Orange/ Mesh Layer from 50 to 250mm from the grass surface. This over laid a lower Orange/Lower Sand only layer. The overall thickness of these two layers ranged between 200mm to 300mm
- Crushed Granite Gravel 48mm to 125mm
- 65mm Subsoil Drainage Lateral Pipe System at 0.38% slope and 3m spacing
- Existing Subgrade - found some road base but mainly appeared a gravelly clay material

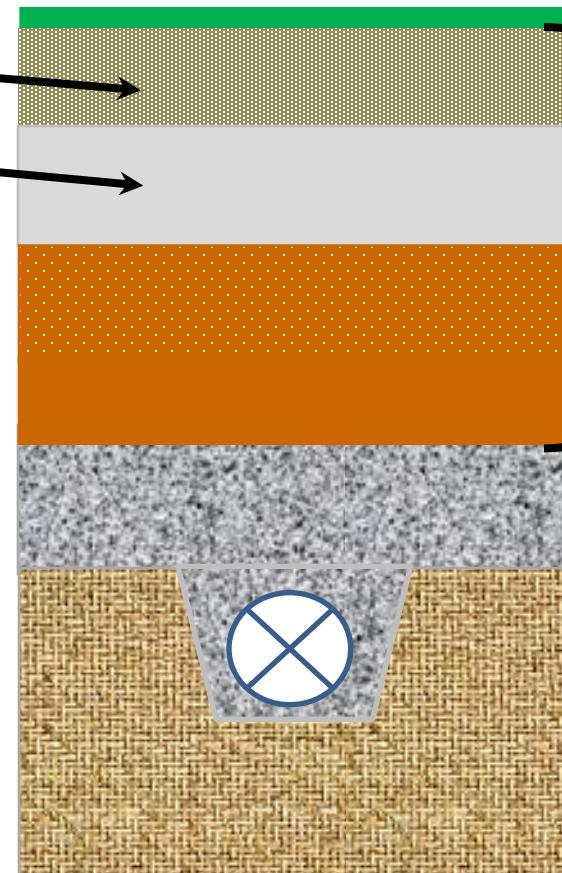
EXISTING PROFILE

Major issue: non uniform drainage

The overall thickness of the root zone above the gravel ranged from 350mm to 490mm

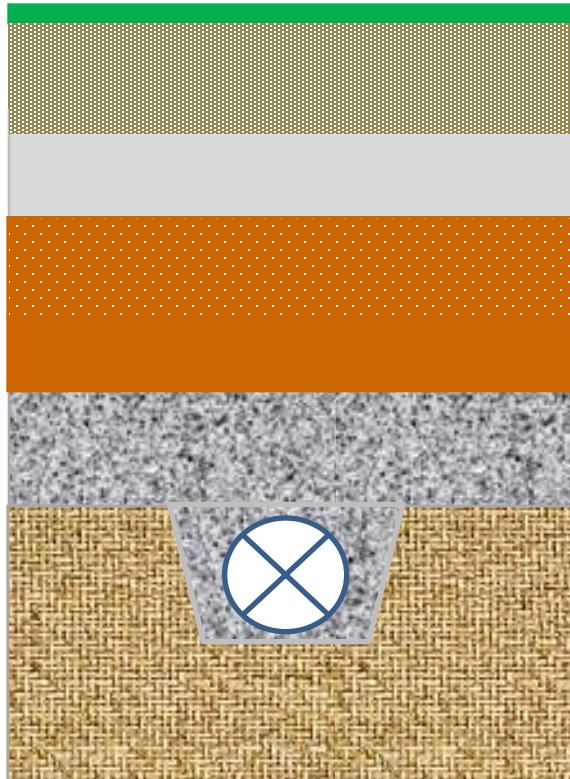
## 2. Profile Study - Top Dark Layer (Result of poor maintenance)

- ✗ Silty sand containing **3.0 % - 9.4 %** organic matter
- ✗ Very poor drainage (**1mm - 40mm/hr.**) & water can't infiltrate this layer
- ✗ Variable depths (50mm - 130mm in thickness, ave 99mm)
- ✗ Foul (anaerobic) smell for some samples
- ✗ Extended time to dry the profile after rain
- ✗ Cut up easily during play in wet
- ✗ Difficult to develop sustainable deep roots
- **Initial thought - this top silty sand layer material should be removed**

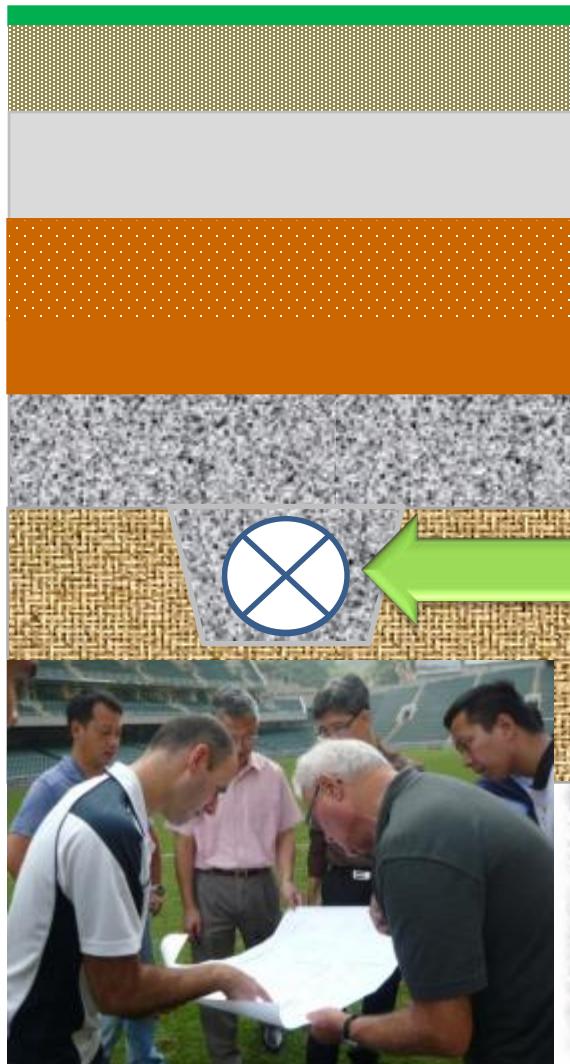
### 3. Profile Study – Drainage evaluation

- ✓ each side of the field drain over 100mm/hour (white dots)
- ✗ center of the field drains at 18mm/hour (yellow dots)
- Design range should be at least 150mm/hr.
- Note- Lateral drainage system is inadequate for the Hong Kong climate

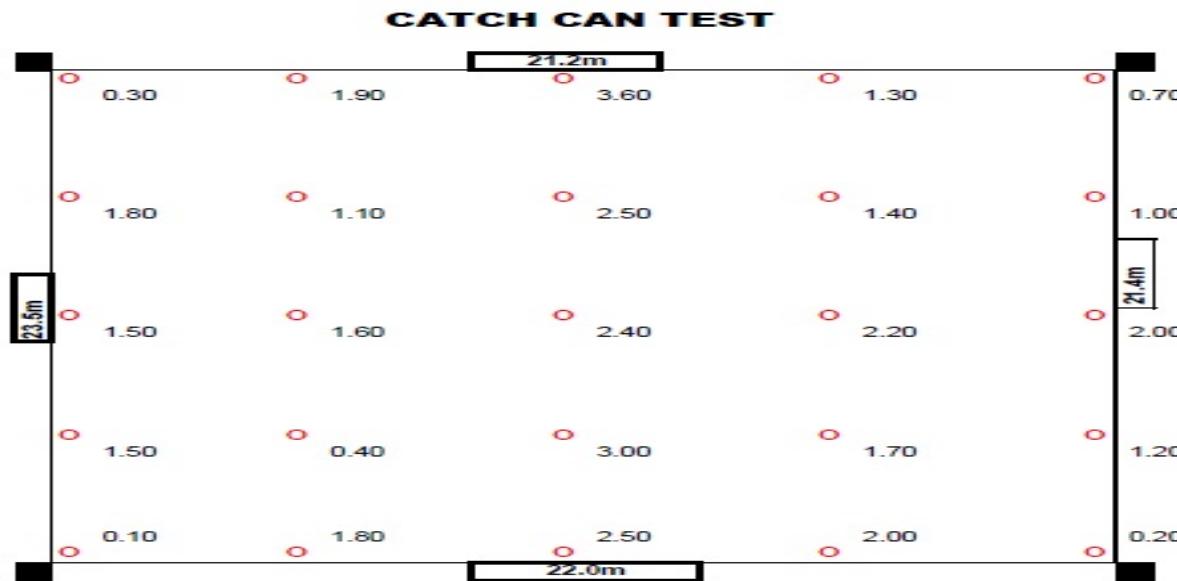
# Can Test

**9.53      Precipitation rate (mm/Hr)**

**CU    57.9%**

**DU    32.5%**

**SC    3.1**

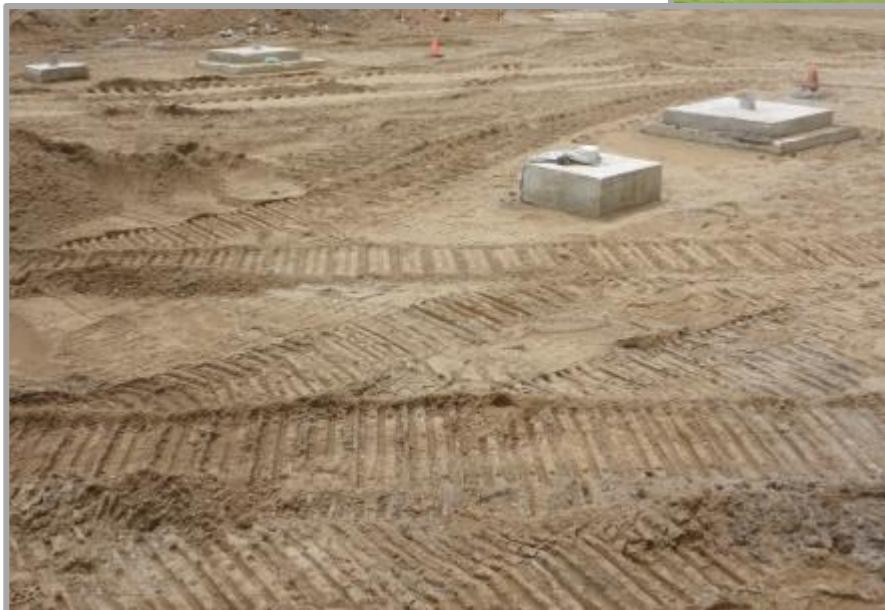
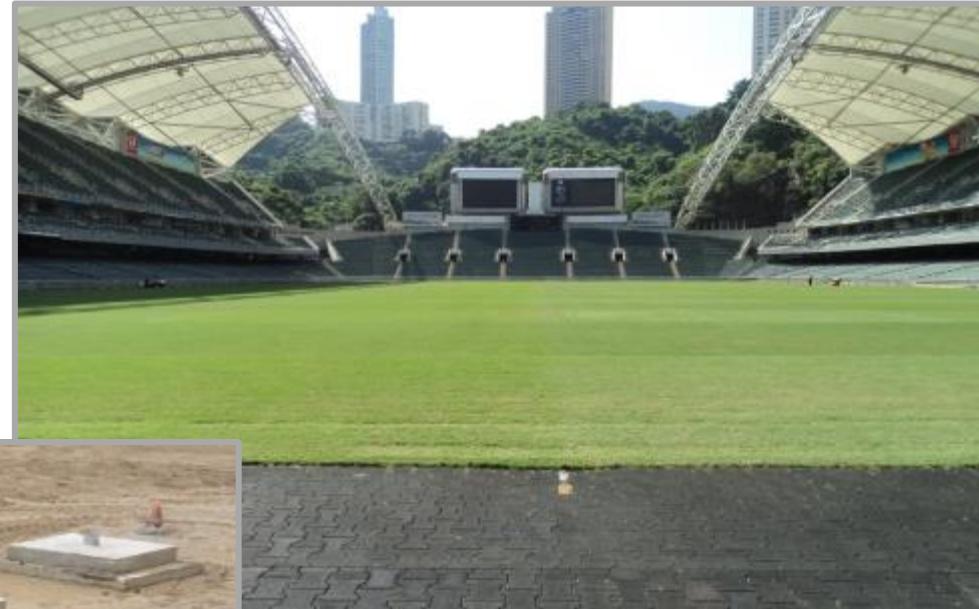
# Surface Slope

Needed to fit to rubber surrounds an goal post sleeves levels while still producing sufficient grade for the drainage and some surface drainage.

Grades placed into 3D total station layout in order to laser grade all pavement layers to the pitch surface grades and to the tolerances required.

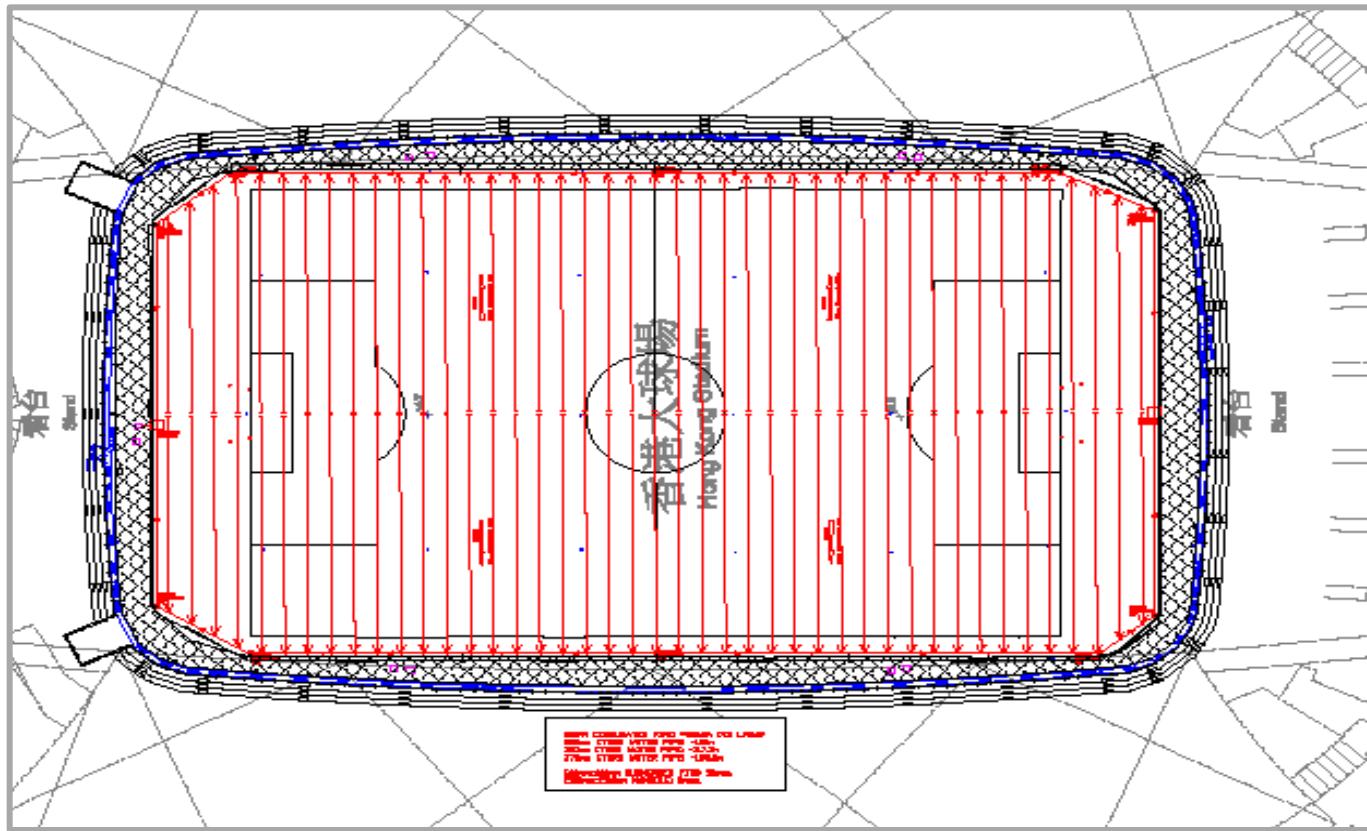
# Drainage Layout

- Main drain with double lining pipe of various sizes to provide the rigidity with little resistance for water flow
- Lateral system connected to main drain pipes surrounding the edge of the pitch
- Main drain discharge at the south and north curvet
- Save cutting rubber pavers
- Design to cope with 150mm of rainfall per hour

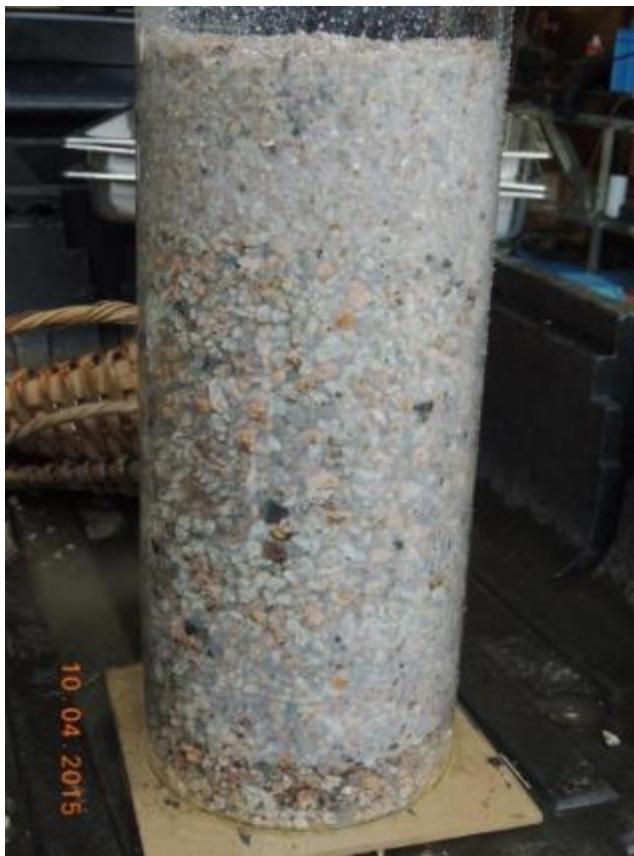
# Further Gravel Testing

Migration testing of F gravel on 10mm gravel.  
No migration occurred.

150mm lateral pipe tested for migration of gravel F if placed around pipes. Pipe covered in gravel and then vibrated and shaken with and without water applications. No migration of gravel entered into the pipe through the perforations.

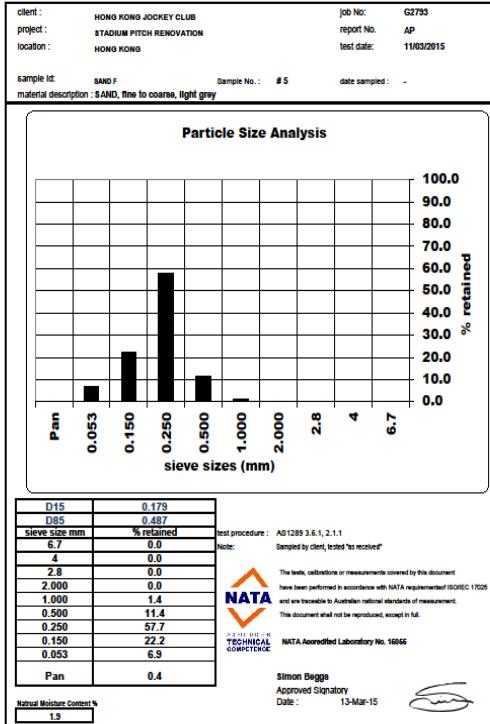
# Particle Size Analysis and D15 and D85

sieve size mm	% retained
D15	0.179
D85	0.487
sieve size mm	% retained
6.7	0.0
4	0.0
2.8	0.0
2.000	0.0
1.000	1.4
0.500	11.4
0.250	57.7
0.150	22.2
0.053	6.9
Pan	0.4

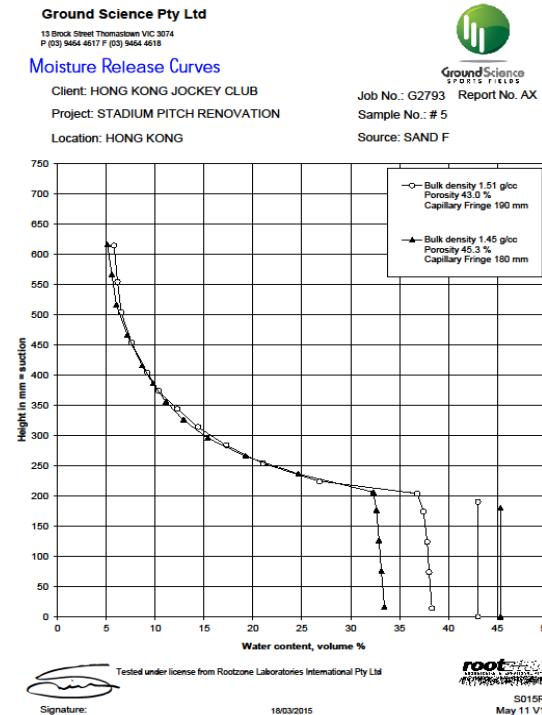
# Moisture Release Curve Testing

At the proposed depth of the growing medium of 250mm plus the gravel suction (68mm), the moisture release curve indicates a moisture retention of 15 % by volume.

This is too low and needs an organic amendment to assist in lifting this to a higher level.

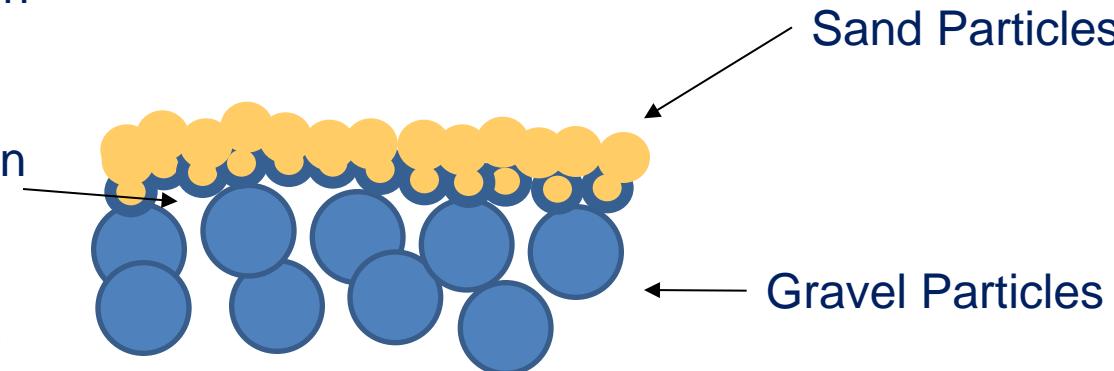
# How the Perched Water Table is Formed

A meniscus is formed by the water held on the sand particles over the gravel air space that is broken by forming a head pressure of water above the gravel in the sand.

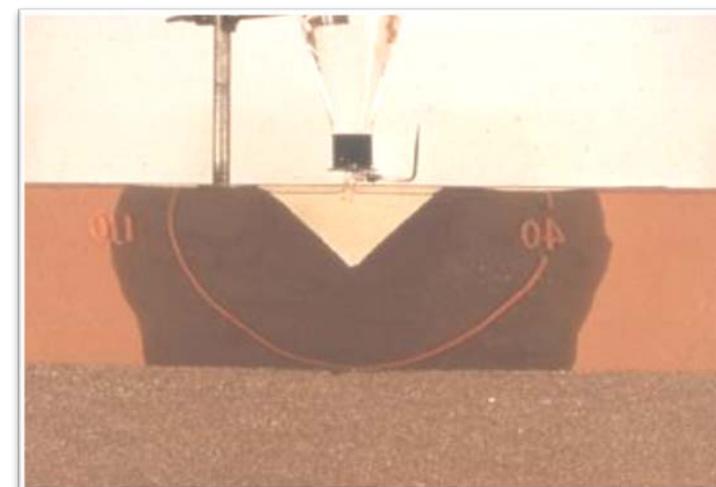
A water reserve is created by the gravel in the layer above.

This will maintain an even moisture in the above sand layer over the whole pitch.

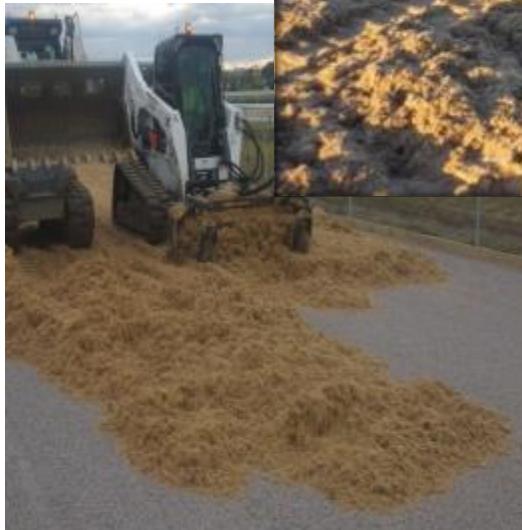
# Maintaining Perched Water Table During Installation

It is important to maintain a sharp interface between the gravel and the sand above and to maintain some moisture in the sand and gravel to ensure the perched water table is achieved during the installation.

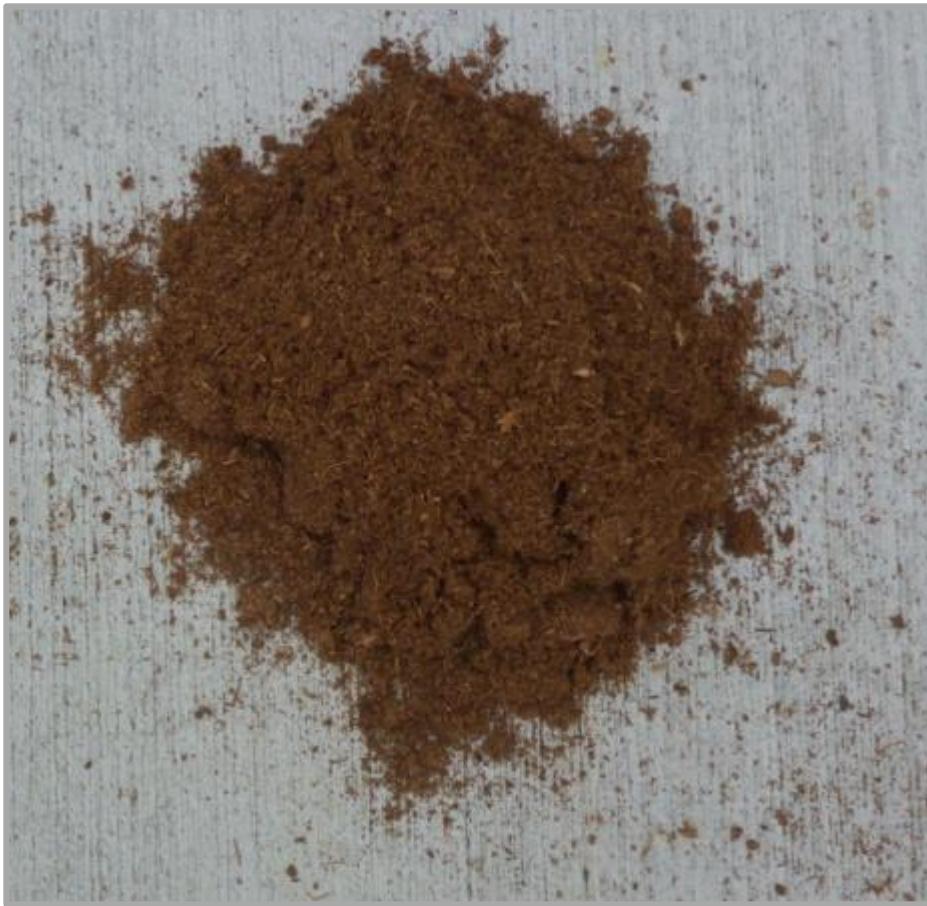
# Peat Moss Amendment

Mainly used to provide better moisture retention, root hair production and some additional stability to the sand.
